# OVERVIEW ON GAS DISCHARGE OCCURRING IN AIR INSULATED METAL ENCLOSED SWITCHGEAR

## ABSTRACT

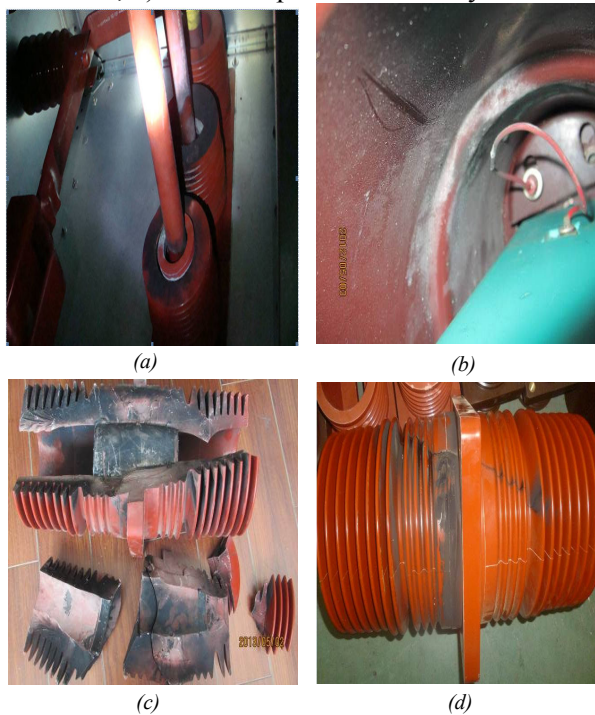
Fig. 1 Different air discharge appearances occurring in bushing.

As showed below Figure 1, different fault and failures will appear in the operation field of bushing. Of course, these faults would be caused by different root causes. Operation experience shows that main fault and failure types commonly include: 1) Irrational product design (not outlined in this paper), 2) Manufacturing process of product is out of control, 3) Severe service condition, 4) Incorrect product assembly.

See from Fig.1 (a) below, we can know that root cause of this fault occurring between two phases of bushing is incorrect product assembly: insulation support plate is not safely fixed with busbar and bushing, due to the wrong assembly, electrical field distribution around busbar inside bushing can change sharply. Consequently, partial discharge will exist around busbar inside

bushing. Therefore, insulation material nears the location of partial discharge will be gradually aged. At the same times, high electrical stress will appear around the aged insulation material. With the further development of partial discharge, insulation performance of bushing becomes more deterioration. Finally, single phase partial discharge transfers to the flashover appearing among two phase bushing.

As showed in Fig.1 (b) below, partial discharge occurs inside bushing, the root cause resulting in the partial discharge is the severe contamination inside bushing. Specially, connection wire between busbar and bushing touches nearly with the interior surface of bushing. Under the influence of severe contamination, partial discharge arises near interior wall of bushing and connection wire, with the continuous development of partial discharge, the insulations performance of bushing will degrade. Finally, the insulation faults appear as that showed following figures.

We can know from Fig.1(c) and (d), the interior insulation fault occurs between high voltage ring and grounded ring used to grading the electrical field. The cause leading to the insulation failures is wrong assembly before casting, this wrong results in the higher electrical field strength in critical position of bushing. Corrent and wrong assembly pictures of grading ring were showed in Fig2(a) and (b).

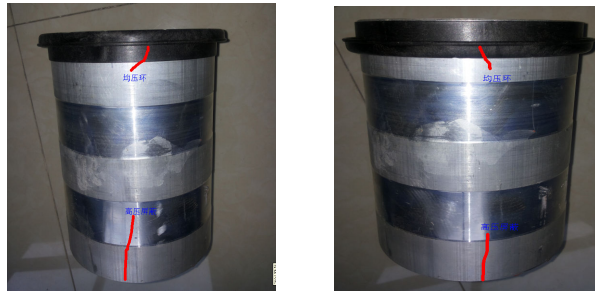
(a) (b)

(a) Correct assembly of grading ring

(b) Wrong assembly of grading ring

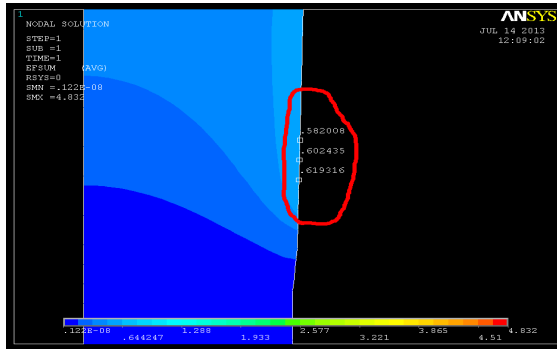
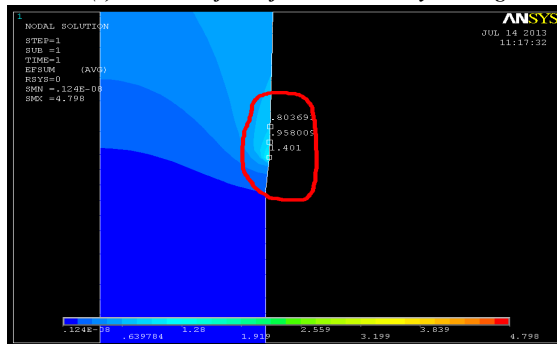
Fig. 2 Electrical Field Simulation on Key Position of Bushing.

In this paper, simulations of electrical field were completed for analysing two different assembly of grading ring. Simulation results were present in Fig2(c) and (d). we can know from simulation results showed below that the electrical field strength of critical position of wrong assembly bushing is obviously higher than that of correct

assembly bushing.

(c) Electrician field of correct assembly bushing

(d) Electrician field of wrongt assembly bushing

For improve the insulation performance of air insulated metal enclosed switchgear, some FEA simulation and electrical tests were implemented in this paper(shown in Figure2 and Figure4), practical test proven that it is feasible to apply these simulation results to explain the root cause of failures.

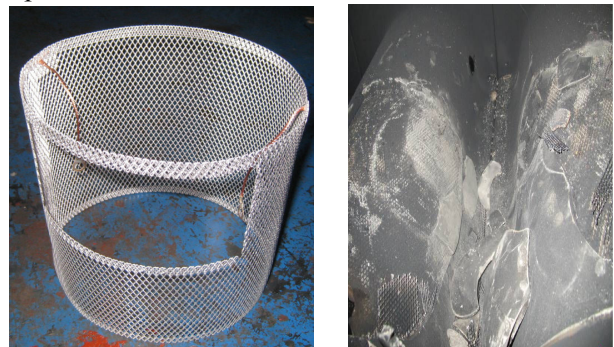
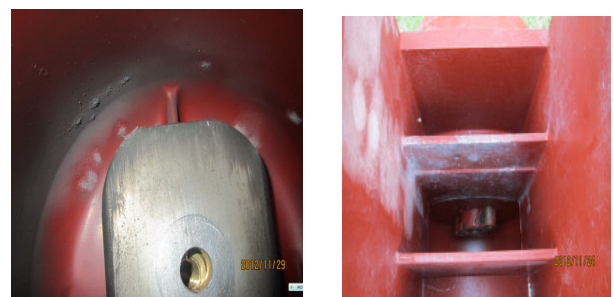
Fig. 3 Air discharge appearing in spout

Normally, some common insulation faults will occur in service field of spout used in air insulation metal enclosed switchgear, some fault types were present as following Fig.3.

electrical field distribution around the end of static contact. Fig3 (a) shows an example of grading ring. Though the design can improve the partial performance of the end of fixed contact inside spout, but there is a pitfall of electrical field which exists between phase and phase, therefore, the electrical stress of the gap between phase and phase will sharply rise, the distribution of electrical field had change comparing to that when there is not grading ring embedded in spout. Under the influence of the severe operation environment: high humidity and heavy pollution. Air discharge of gap between phase and phase will occur. Partial discharge will lead the aging of epoxy resin of spout. Consequently, the aging result in the poor insulation performance of spout, with the future development of partial discharge and aging, finally, the fault of short circuit will lead to the failure of insulation performance of spout.

discharge. Eventually, it is possible to result in the insulation failure and insulation aging. As showed in Fig3(c), the sharp end of busbar inside spout leads to partial discharge.

Good product and design maybe also be possible to lead to insulation faults, the root cause is incorrect product assembly in the workshop, the real fault picture as showed in the Fig3 (d).

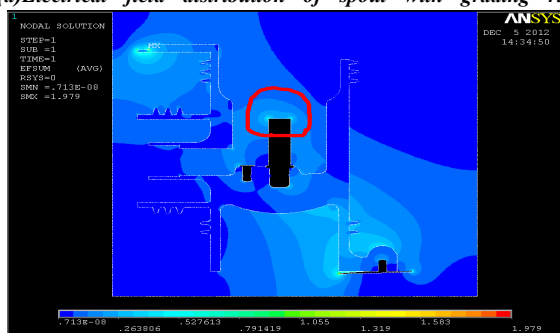
Fig. 4 Electrical Field distribution of spout

Based on the description present in 3.1, some simulations were implemented on spout with grading ring and without grading ring, simulation results were showed Fig4. We can find two figures from the simulation results as following: 1) corona discharge of fixed contact used in spout with grading ring can be successfully be eliminated, 2) at the same time, electrical field distribution among gap between two phase spouts changes sharply.

(a)Electrical field distribution of spout with grading ring

(b) Electrical field distribution of spout without grading ring
