INFRARED IMAGING OF DRY-BAND FAILURE OF SILICONE-RUBBER INSULATORS

M.ALBANO, P.CHARALAMPIDIS, H.GRIFFITHS, A.HADDAD and R.T.WATERS

Cardiff University, School of Engineering, Cardiff, CF24 3AA, UK
albanom@cf.ac.uk

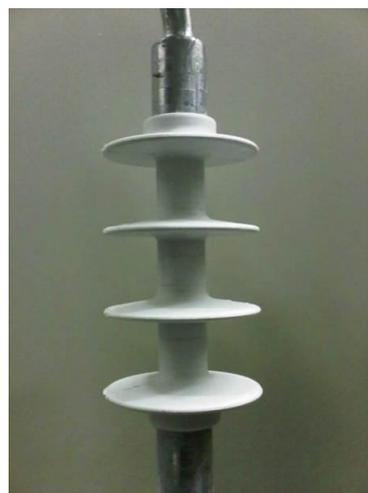
Figure 1 Test insulator

The insulator dimensions (mm) are: creepage length L (375), trunk diameter (28), shed diameter (90) and axial length (175). The form factor F is calculated from integration along the surface creepage path $0 \leq x \leq L$ where the variation of insulator diameter $D(x)$ defines the profile:

(a) Test insulators. The profile employed in the tests is based upon a commercial four-shed 11kV design, and was manufactured in-house (Figure 1).
